Function and Use of a Nineteenth-Century Barn
"Walnut Hill" Estate
Pawling Road, Lower Providence Township
Montgomery County, Pennsylvania

A THESIS
in
The Graduate Program in Historic Preservation

MASTER OF SCIENCE
1991

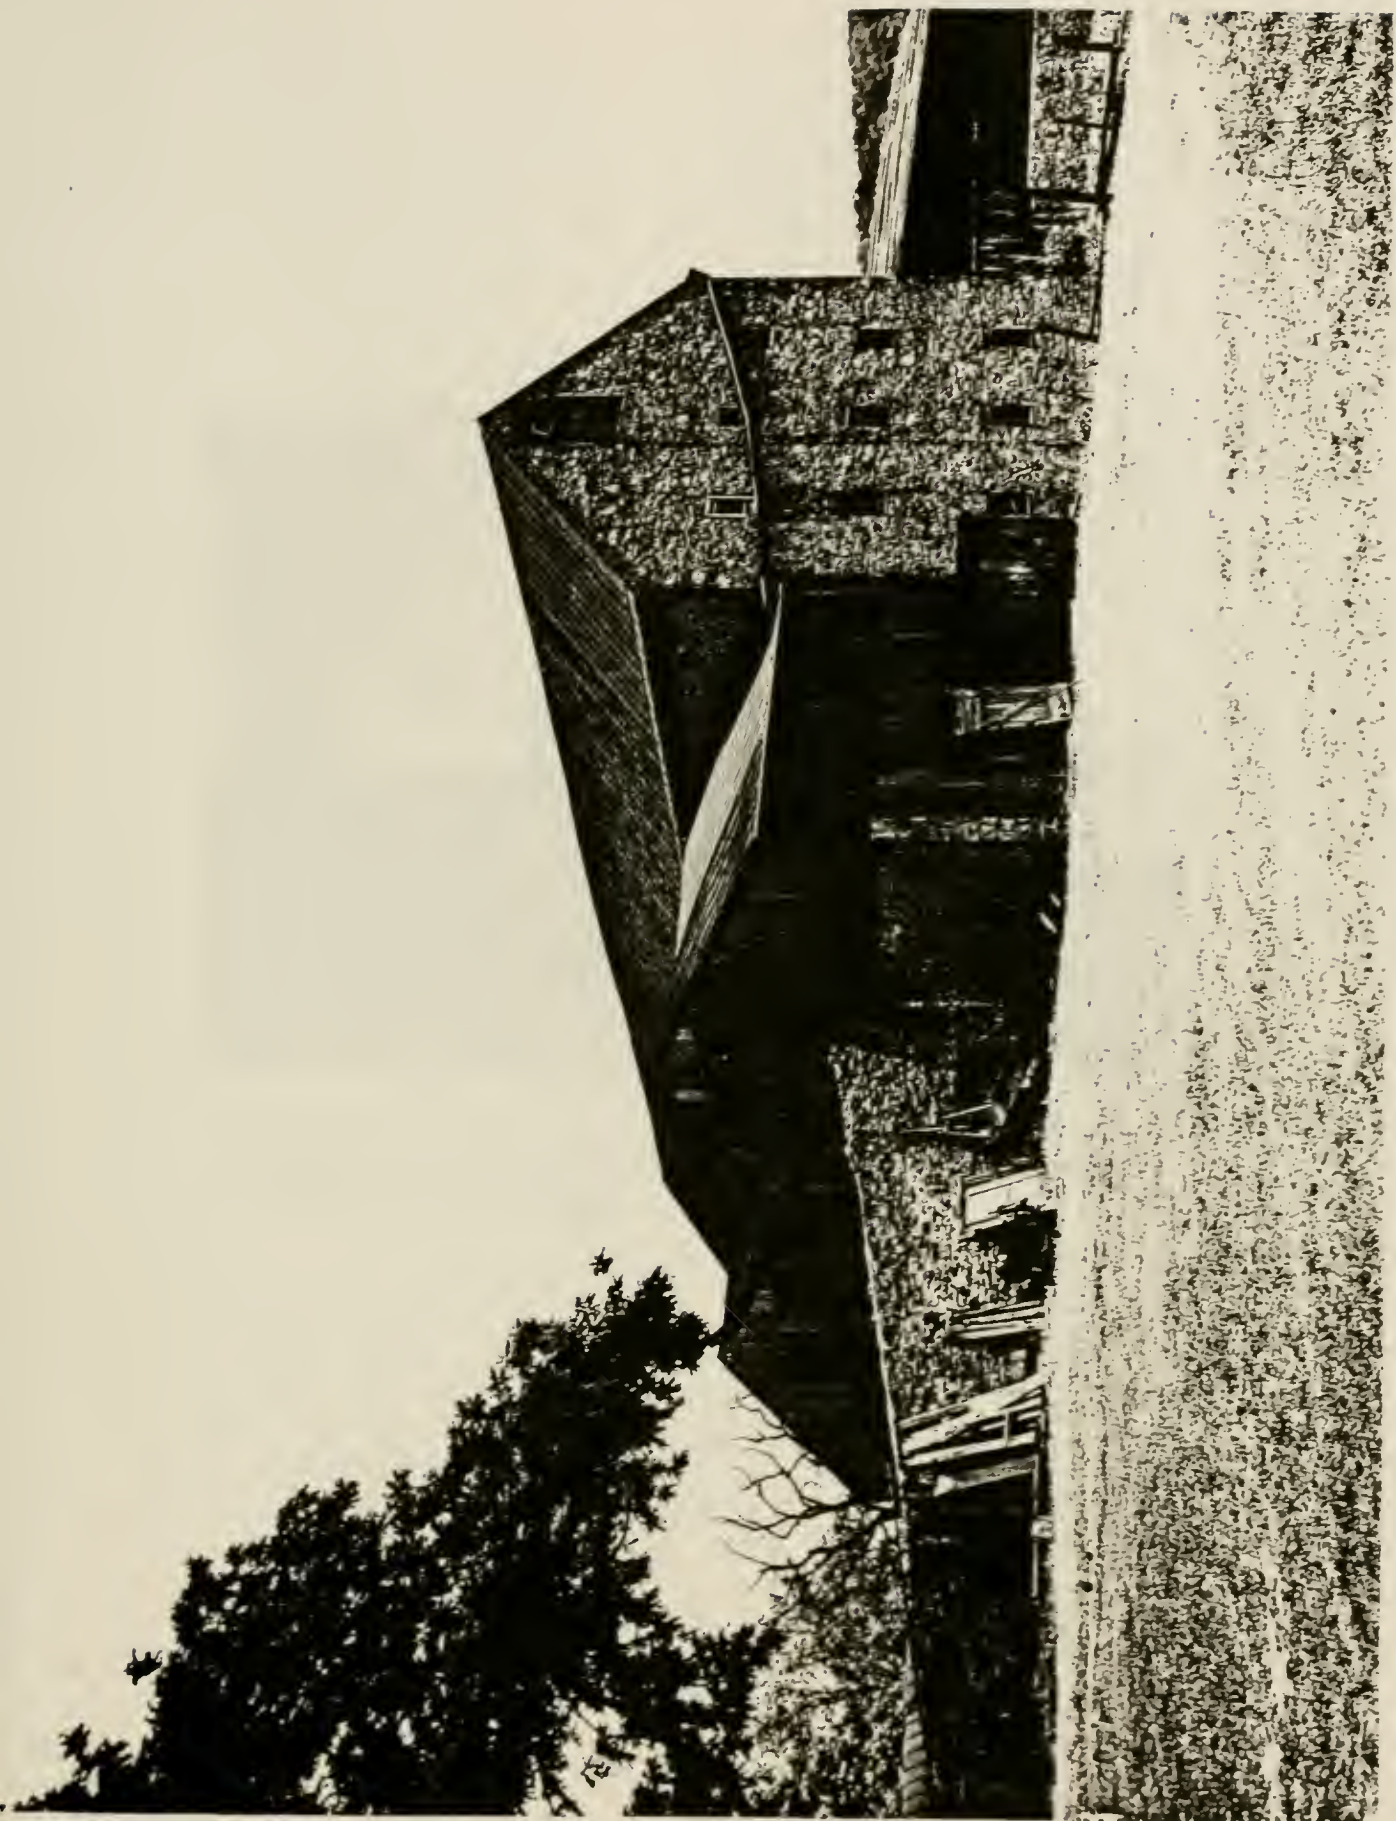
Plate 17: North and west elevations, photograph taken in 1940s by Charles Dornbusch. H.A.B.S. #PA5350-2 (Washington, D.C.: Library of Congress)

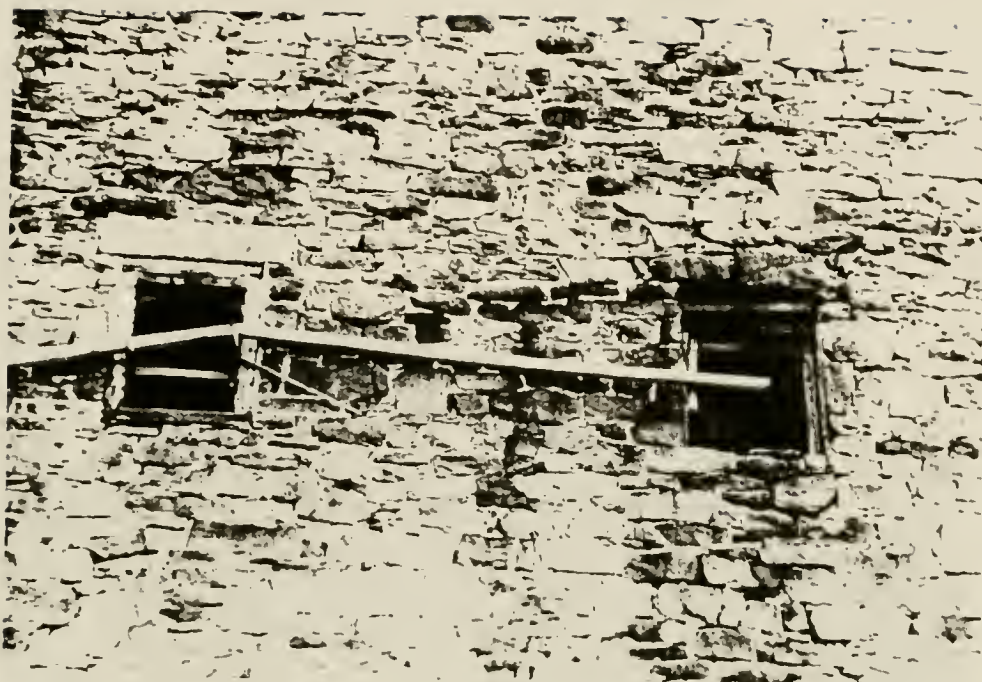
Plate 19: Detail of west gable end windows showing bluestone lintel (left) and sandstone rubble support (right)

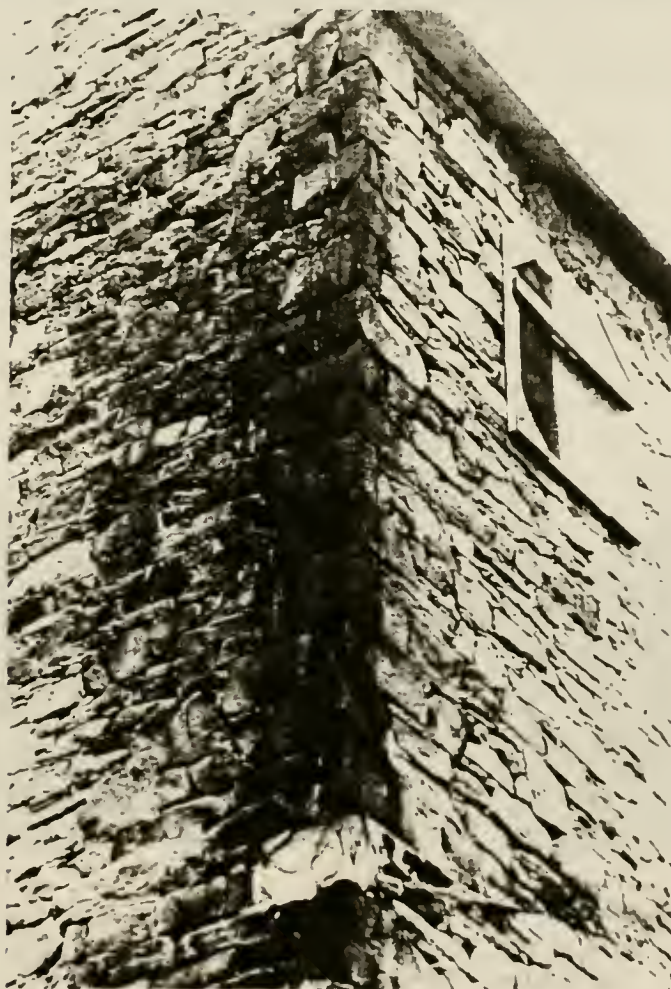
Plate 20: Detail of corner quoins along southwest edge of barn

upper gable portion. Stone quoins define the edges (Plate 20). Bluestone lintels are found on the first and second floor windows, as well as the center window on the third floor. The ridge pointing is still partially visible on this facade, although suffering an advanced state of deterioration.

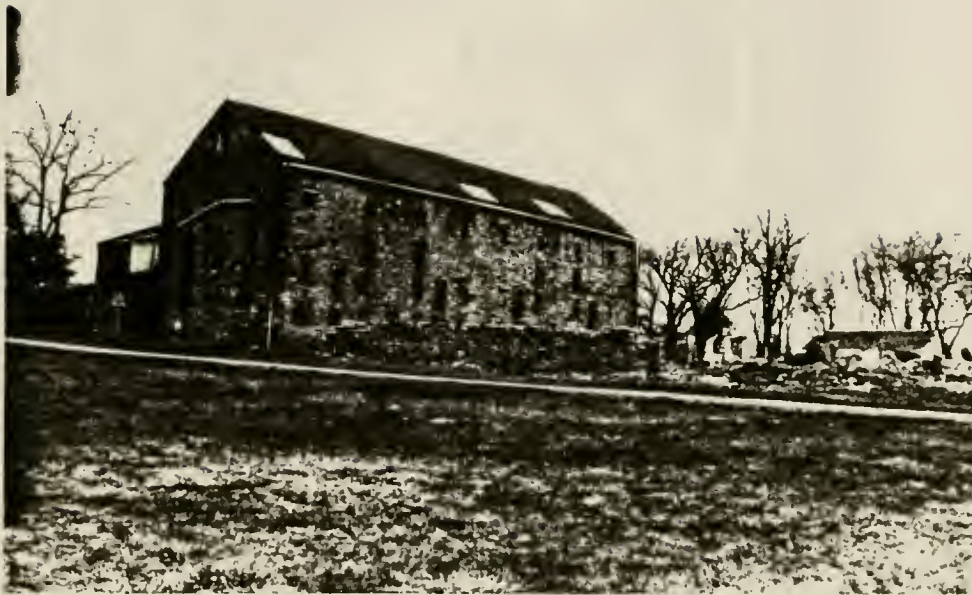
Plate 21: View northeast of south and west elevations, showing corral wall extending from south side

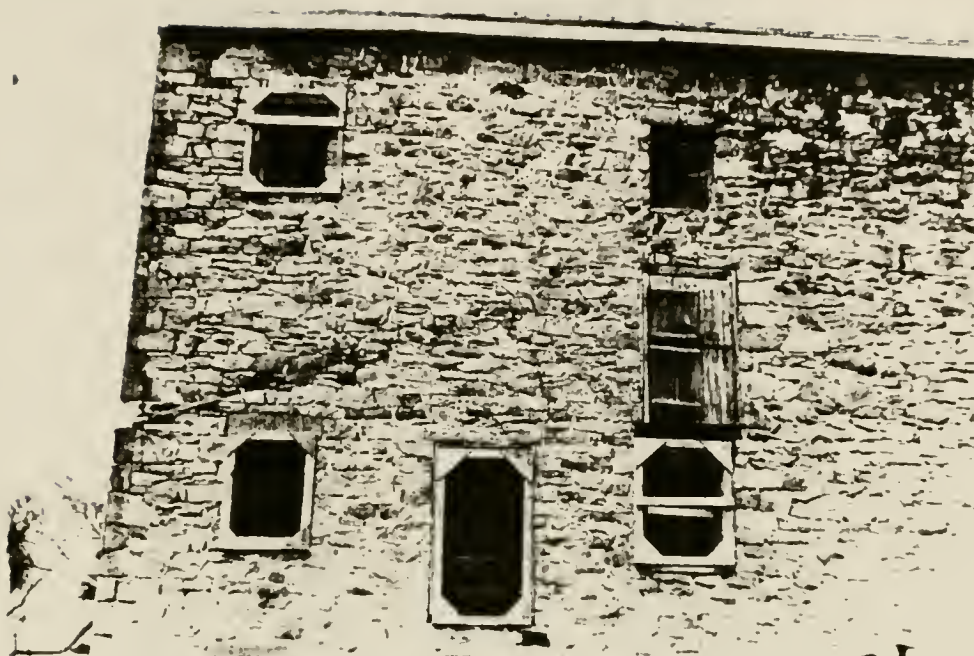
Plate 25: Close-up of 1845 section of south elevation, showing evidence of former "strawshed" roofline which extended along west wall of corral

An enclosed farmyard area, consisting of a low stone wall on three sides, extended from the south elevation and created an open area for the animals to feed (Fig. 12). An opening was centered on the south stone wall, and other openings were provided along the side walls (east and west) near the barn. The west wall has several pocket openings for joists, located approximately 2 to 3 feet above ground level (Plate 28). Nine pockets are evident in the stonework and appear to be found every 3 to 4 feet apart. The northwest section has remains of a concrete foundation, about 4 feet by 10 feet. In the southwest corner, a brick foundation wall is visible as well as remains from a concrete trough. Concrete slabs are located in the ground across most of the length of this wall, except where the concrete foundation and brick foundation wall is located. It is difficult to determine what was original and what portions were later additions. There is also a trace of a previous gable roofline evidenced in the stonework at the west end of the barn wall, which extends to the top of the middle level window. This is the remaining visual evidence of the gable building that once stood along this west wall. A photograph taken in the 1940s by Charles Dornbusch shows a two-story wood building, or "straw shed", that existed along this wall (Plates 23 & 25). The east stone wall has a small section that extends approximately

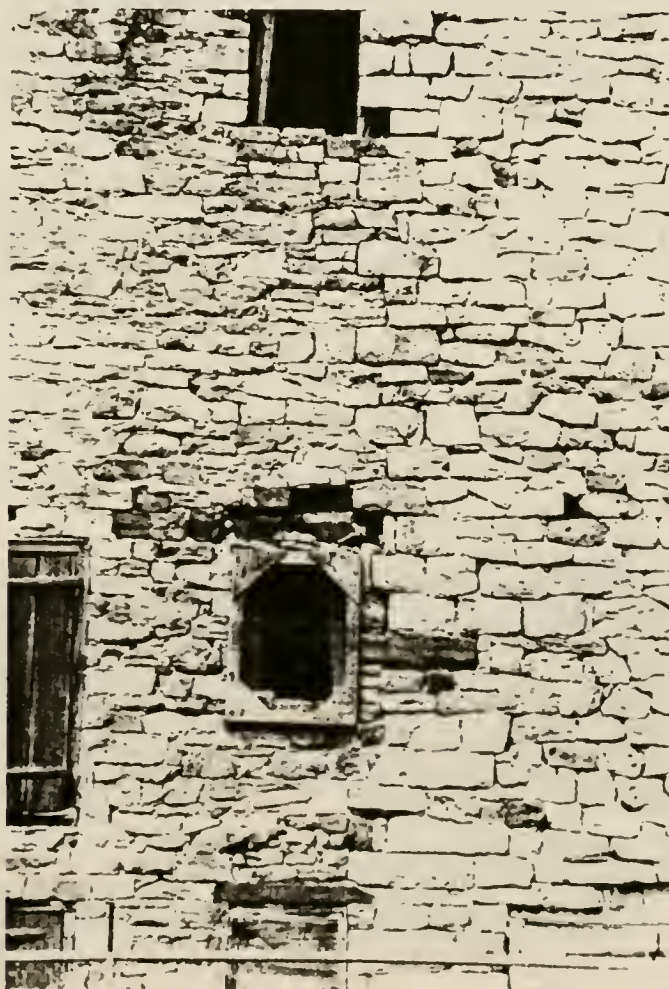
Plate 26: Detail of stone "dovetailing" on south elevation

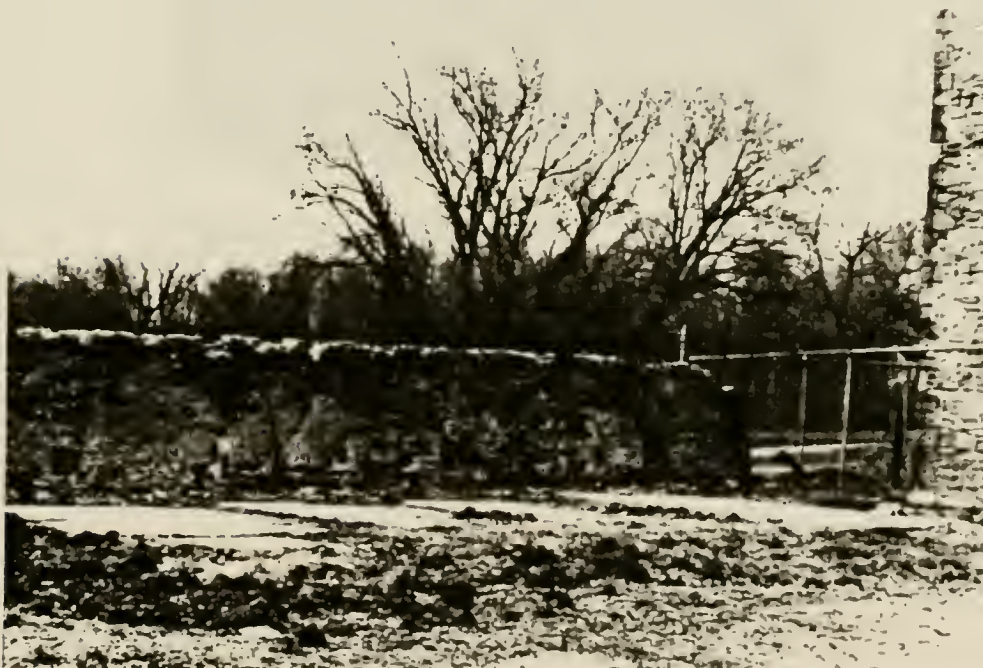
Plate 28: View of west corral wall with pocket openings in stonework

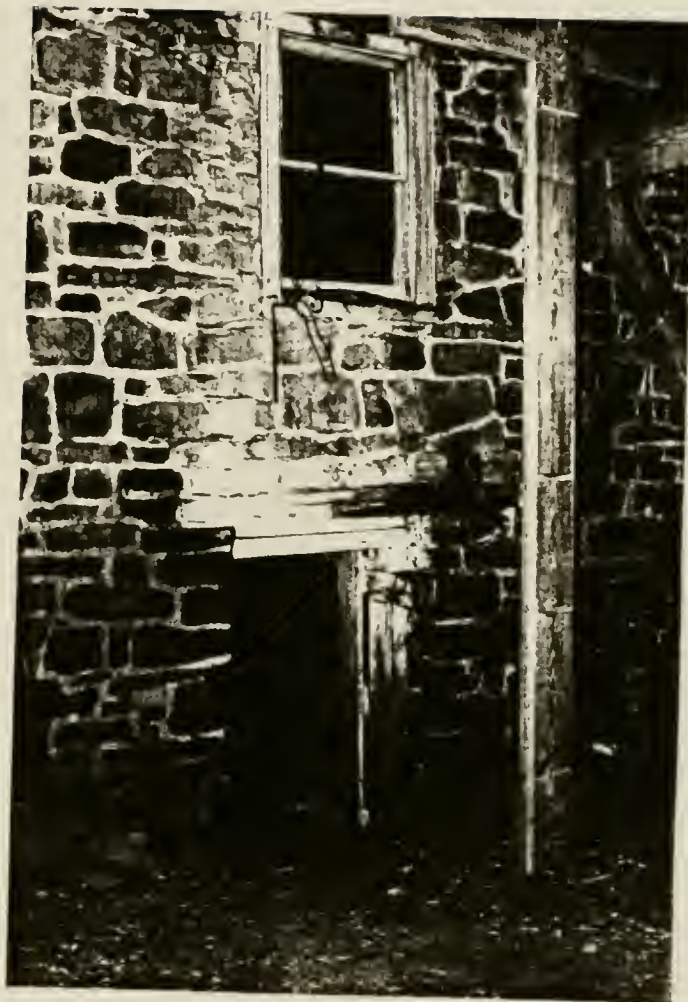
Plate 29: View of north elevation from carriageway in 1826 section, showing door leading into stables and window above into middle level, or granary

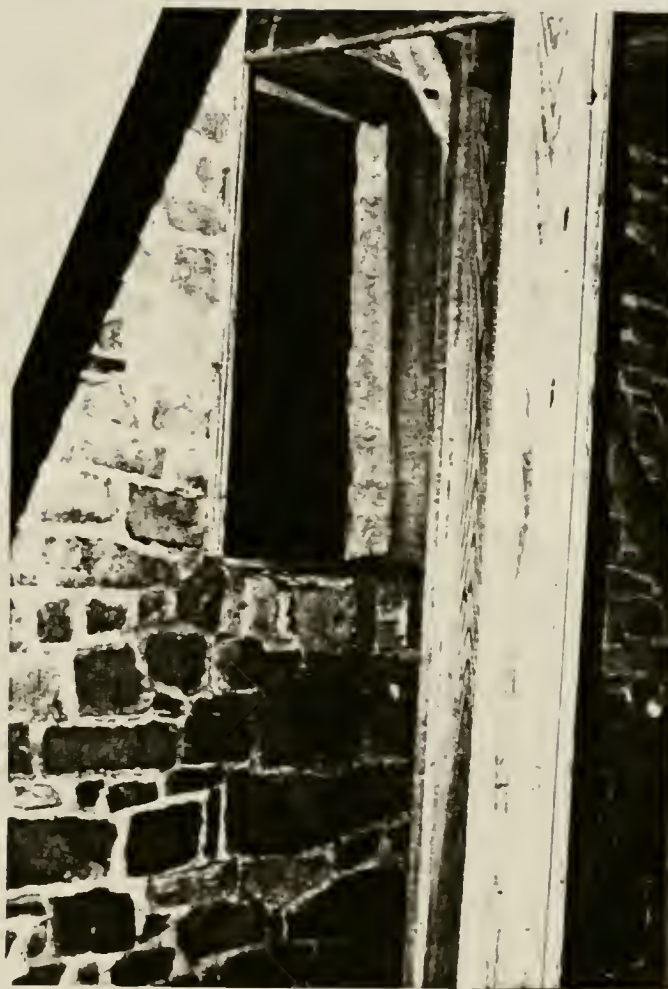
Plate 30: View of north elevation from carriageway in 1826 section, showing door to middle level, which was probably been reached by ladder. A staircase did exist along northeast end of stable area but has been covered over

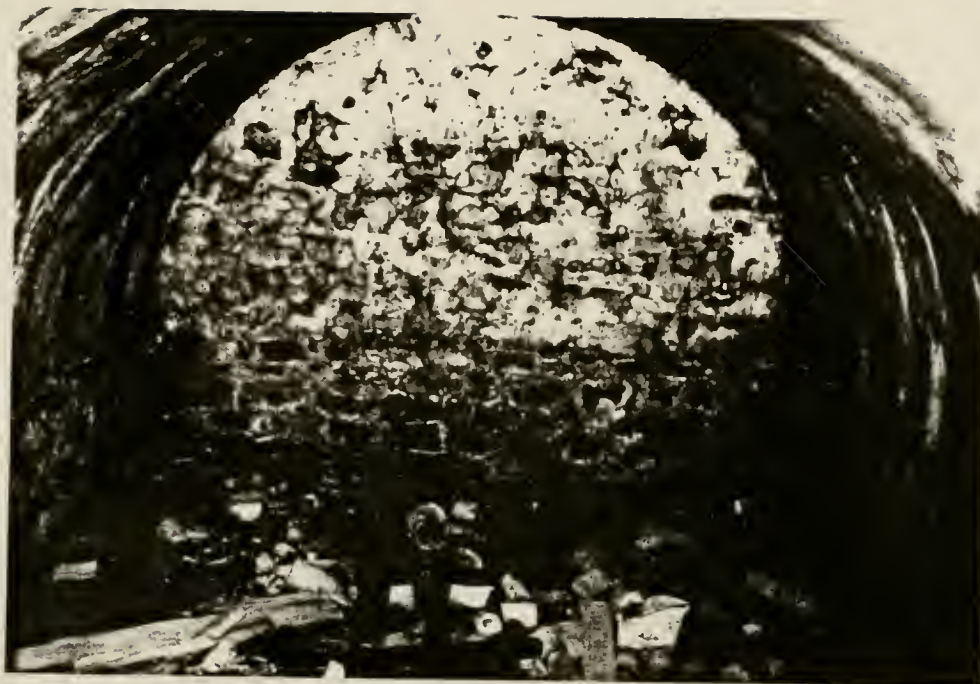
Plate 31: Stone vault #1 in 1826 ramp section, showing depth of room and whitewashed surfaces. This vault was accessed by an exterior door opening along southeast side of ramp retaining wall

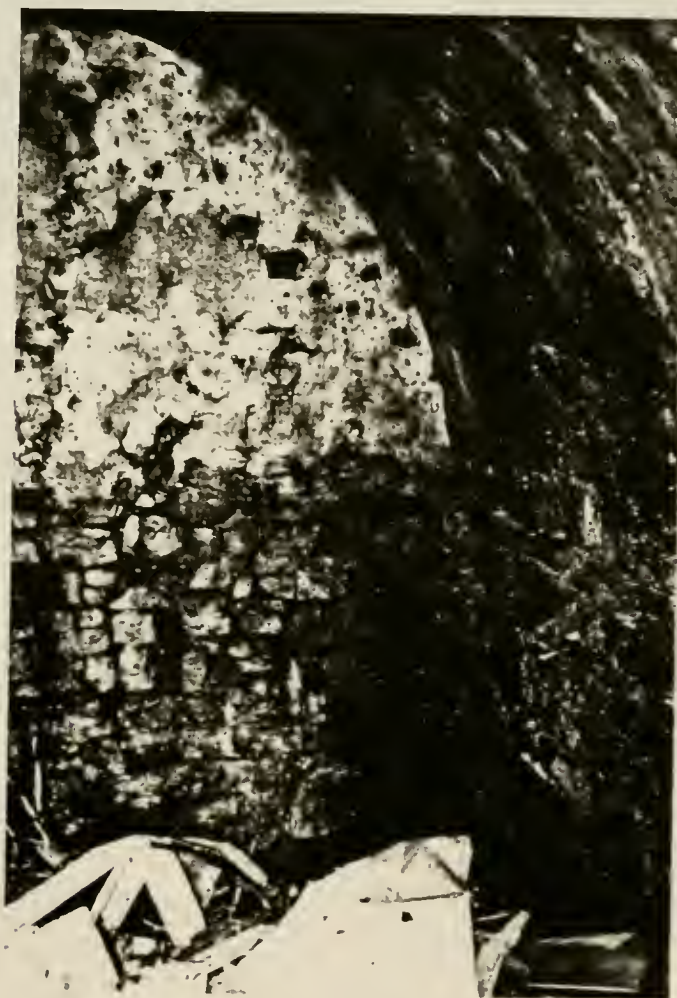
Plate 32: Close-up of stone vault #1

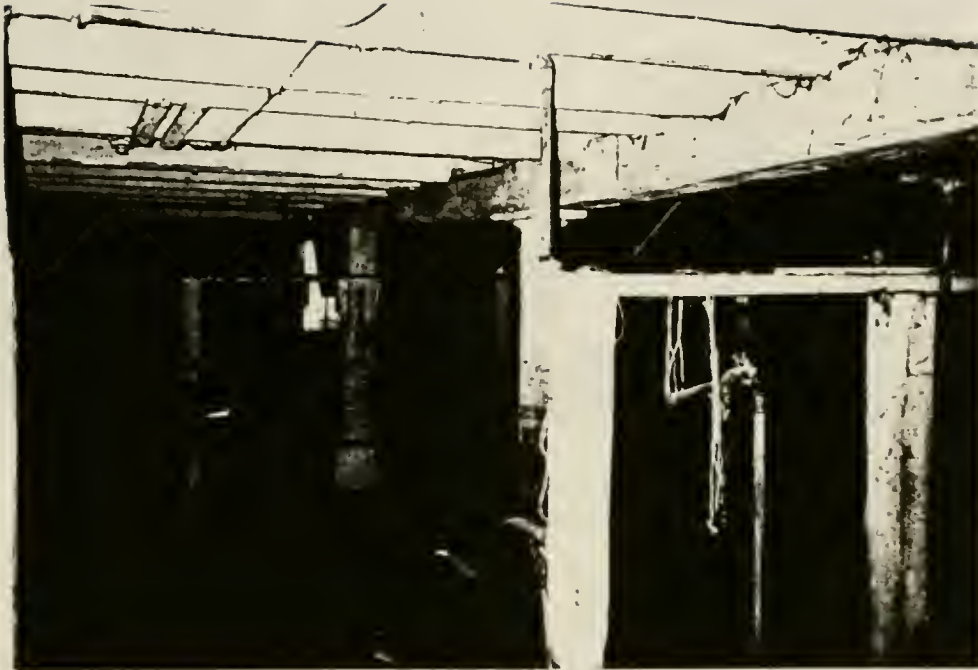
Plate 33: View of 1826 stall area looking east. Section has been modernized to serve as a dairy operation, however, original structural system remains intact.

The 1826 stall area was later modernized to house cattle, with a concrete floor laid down, leaving scant evidence of the original layout of the stall areas. The original whitewashed stone walls and interior structural members are still intact which provide clues to the type of open stall that may have existed in this section before the metal stanchions and new floor was added (Plate 33). Empty mortises are found along several cross beam in the barn,

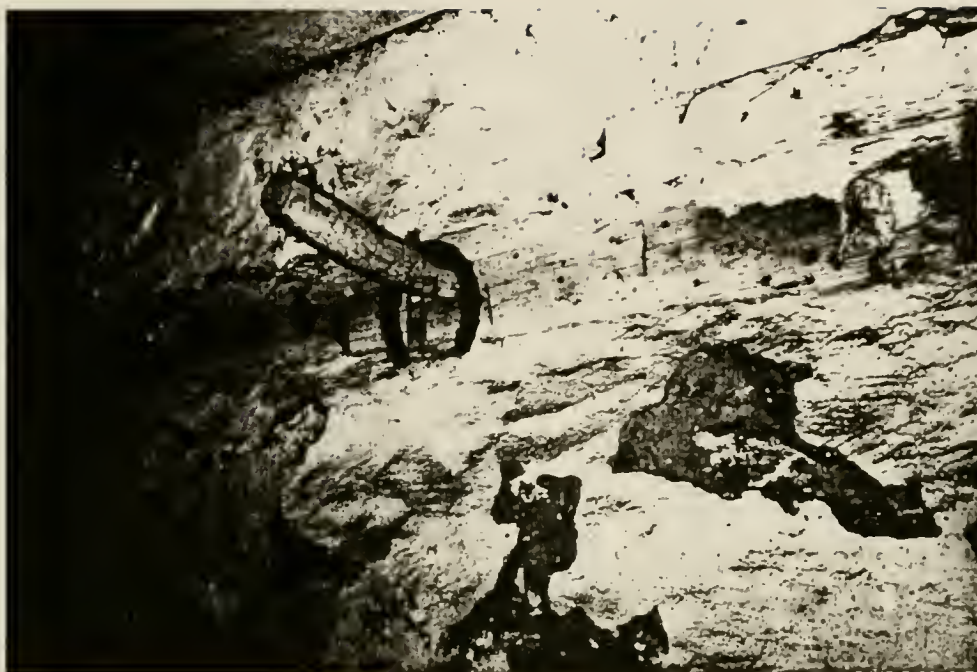
Plate 34: Pegboard embedded in east wall of 1826 stall section. Three pegboards are placed across the wall and would have been used to hang equipment

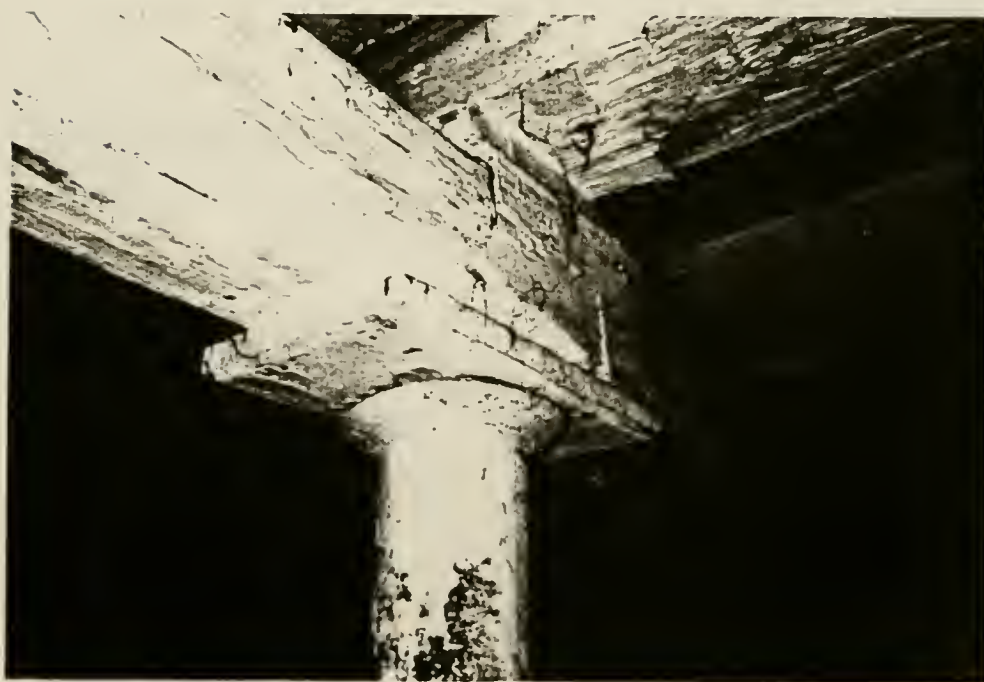
Plate 35: Detail of cast iron column and chamfered beam in 1826 stall section

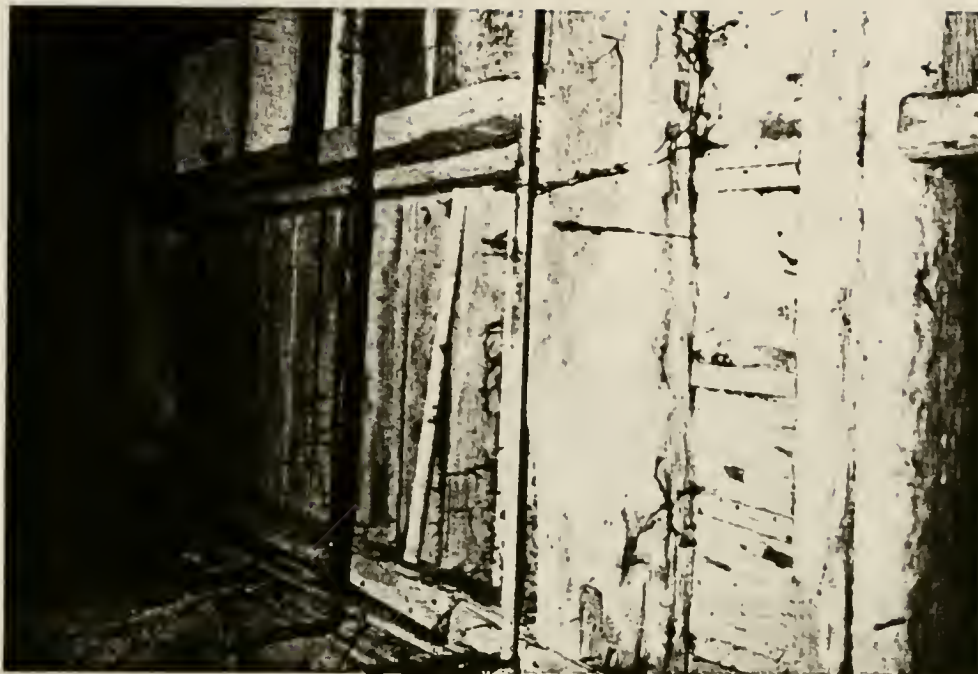
Plate 36: 1826 stall section showing evidence of closed staircase along northeast end, which would have led up to granary level

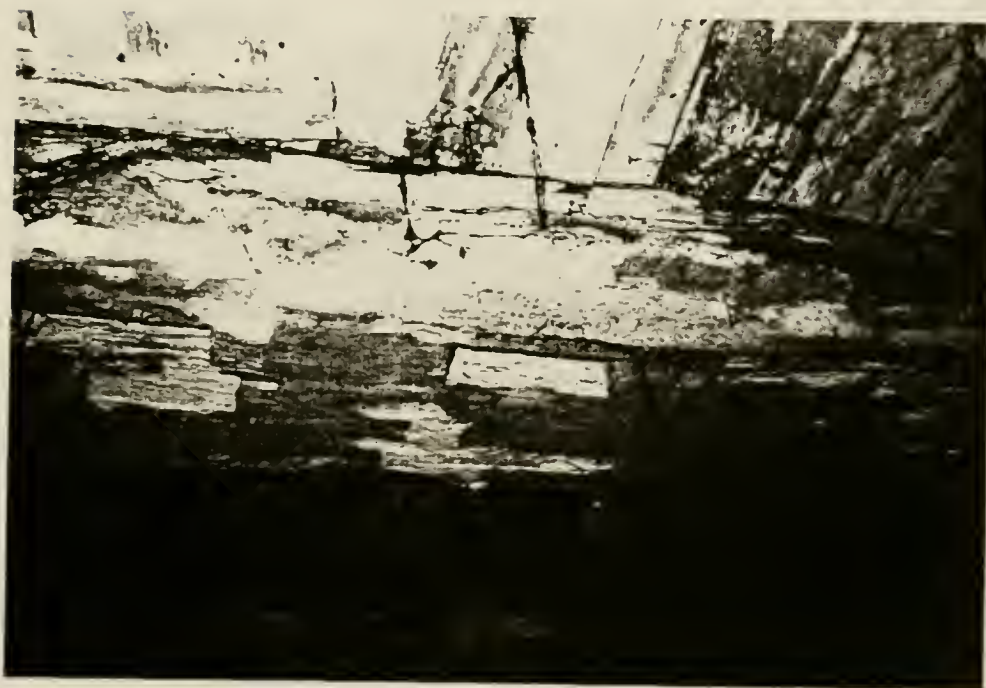
Plate 37: Detail of notches found in cross beam of 1826 stable ceiling framing. Holes may indicate location of earlier stall dividers (Refer to Appendix E for location of notches)

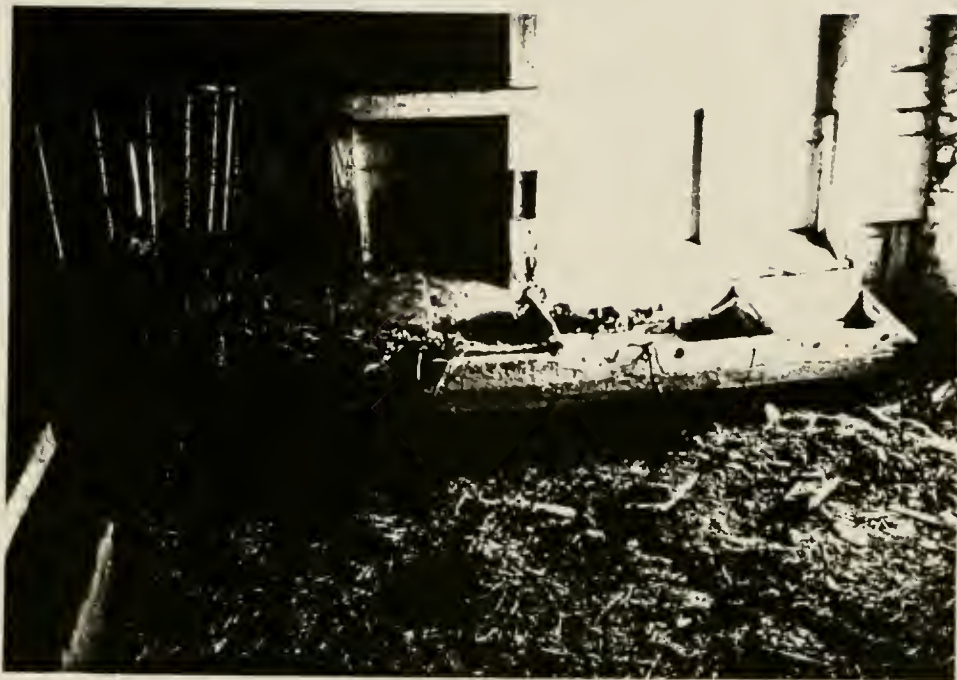
Plate 38: Trough and hay feed still intact in west partitioned section of 1826 stall area

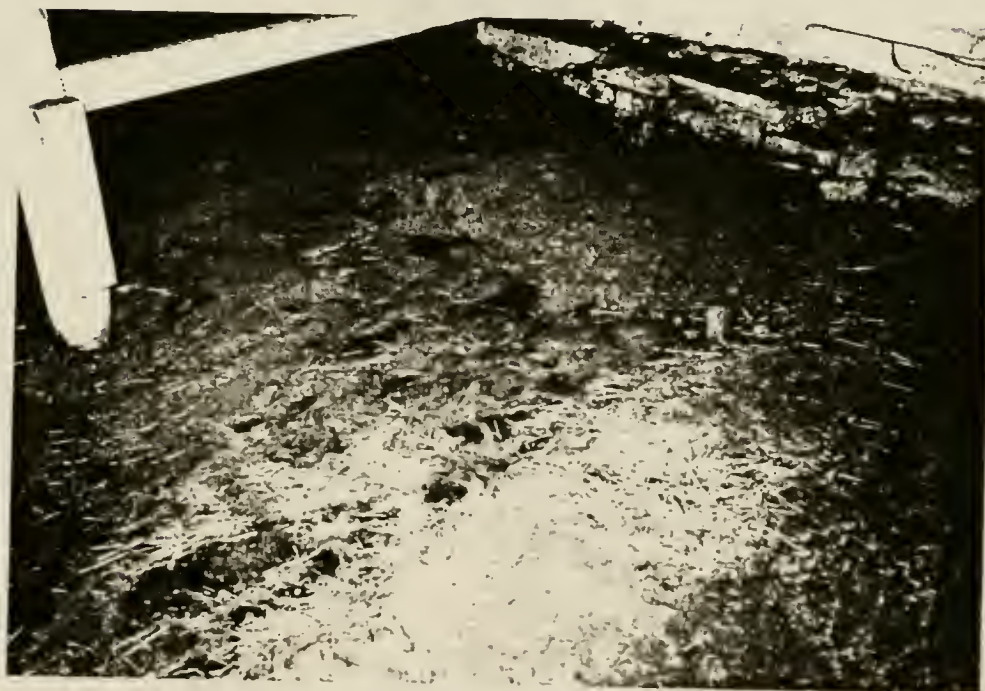
Plate 39: Evidence of cobblestone paving in west end of 1826 stables, uncovered during archaeologist's investigations. Refer to Figure 12 for location of test unit.

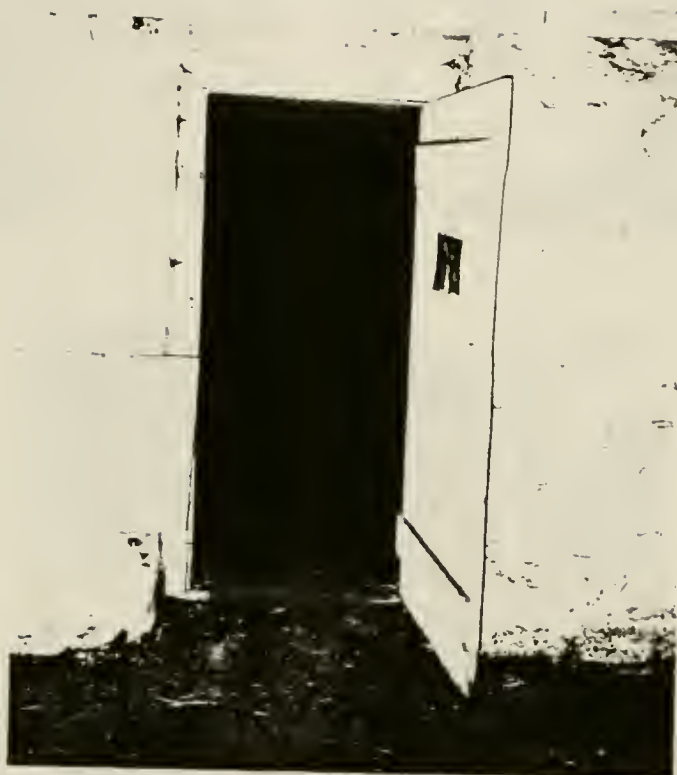
Plate 40: Original exterior door of 1826 west gable end, which now connects to 1845 stable addition. This door opening provides the only direct access between the two sections.

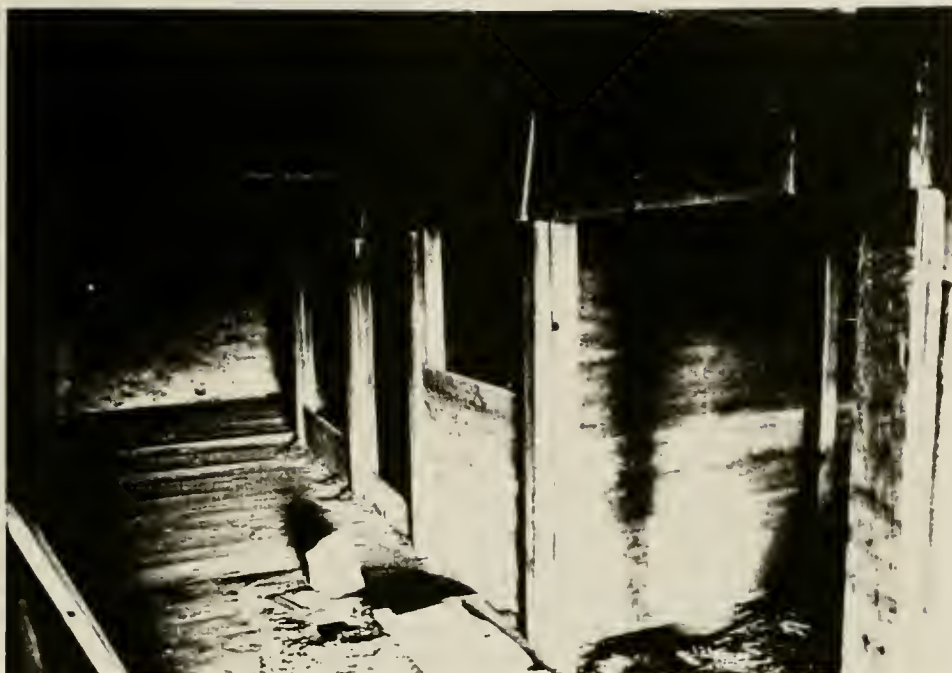
Plate 41: Middle level of 1826 section showing grain bins along midsection

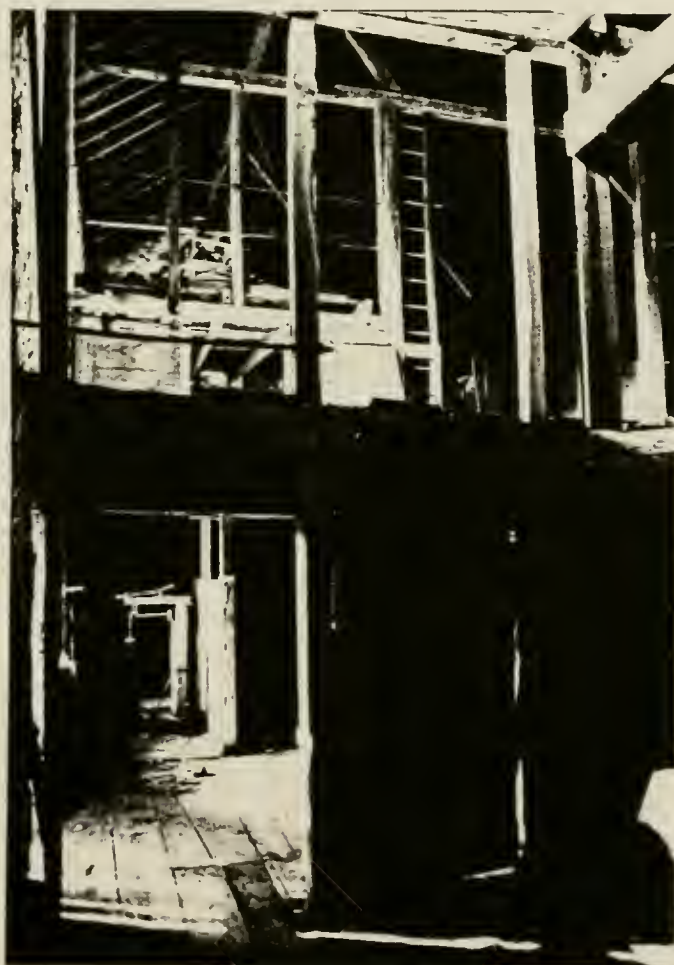
Plate 42: Middle and third floor levels of 1826 section, looking west, showing relationship of "sink-mow" and threshing platform

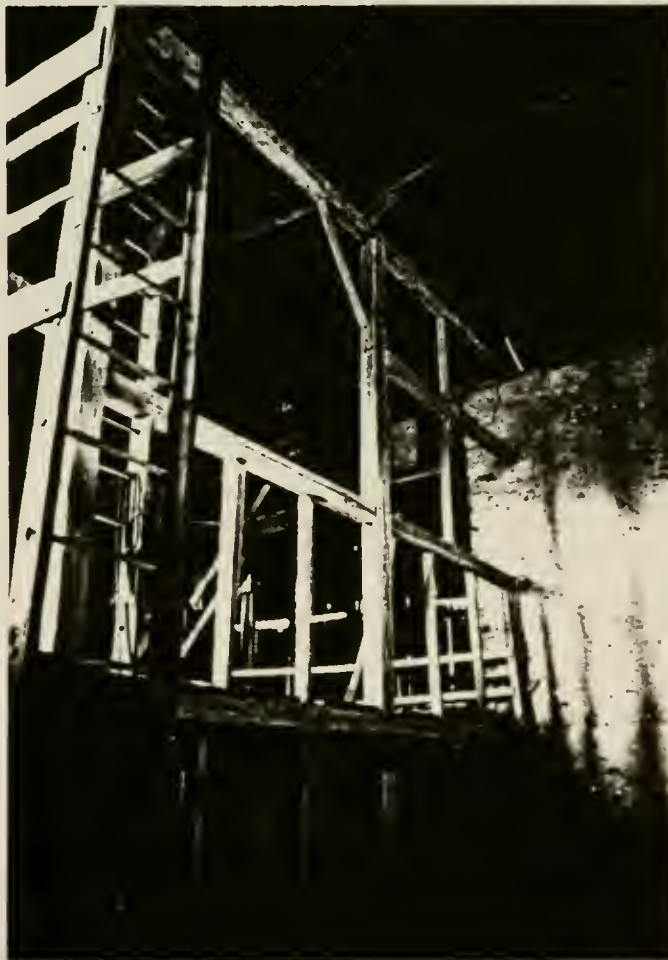
Plate 44: View of east hay mow up to threshing floor and large opening on north elevation of 1826 section

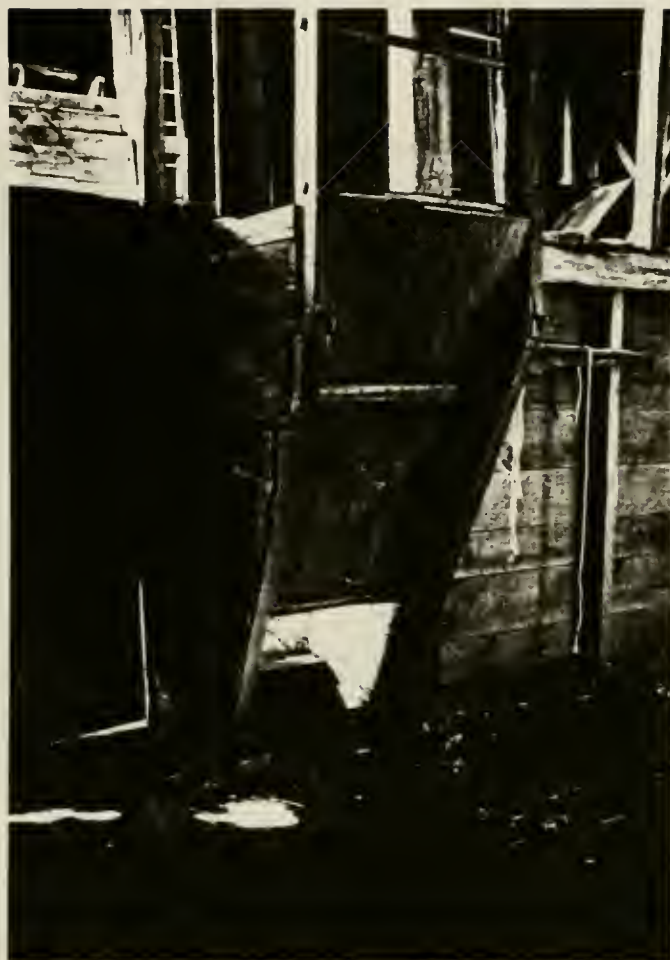
Plate 45: East hay mow of 1826 section, showing close-up of hay chute extending along side of threshing floor to floor below

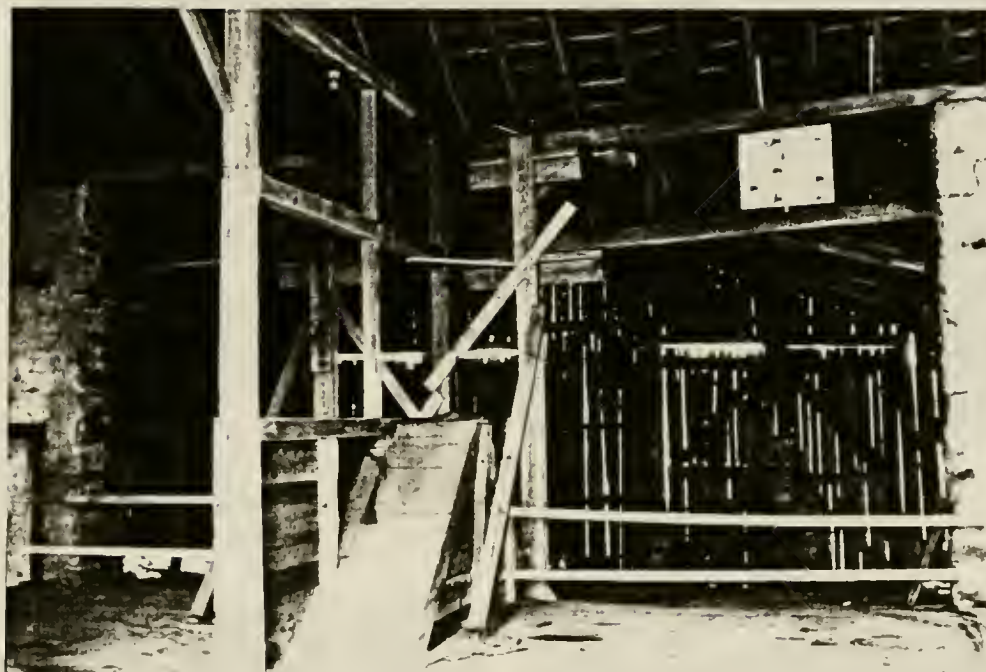
Plate 46: Threshing floor of 1826 section, looking north into rear shed addition. Two sets of double doors lead onto ramp. Note enclosed staircase (center) located in middle of platform. Pegs project from overhead cross beam above stair landing.

A loft area, located on the southwest wall of the threshing floor, may have served as a small storage space (Plate 50). At the northwest end of the platform, wooden pegs project from the tops of two of the framing cross members (Plate 46). Remains of a metal chain and pulley system are still visible along the roof’s framing, directly above the threshing platform, indicating the only remnant of the horse-drawn, and later machine-powered, threshing device that would have been used in this space (Plate 54).

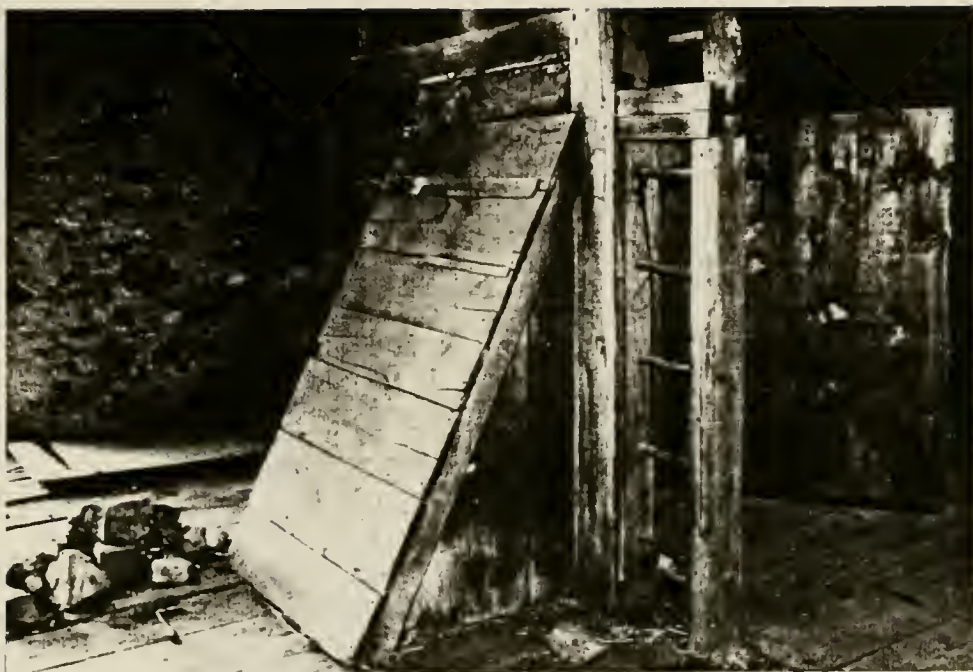
Plate 47: Threshing floor of 1826 section, showing close-up of hay chute and ladder alongside which is integrated as part of framing

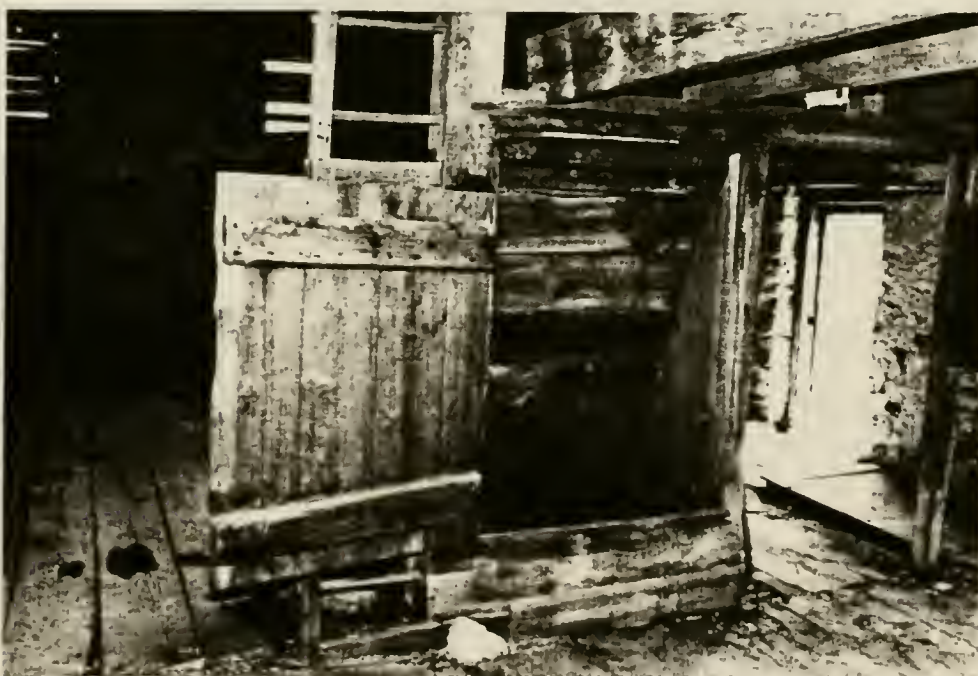
Plate 48: Threshing floor of 1826 section with view of hay chute opening, located along south side of platform. Note left space above which covers part of south elevation.

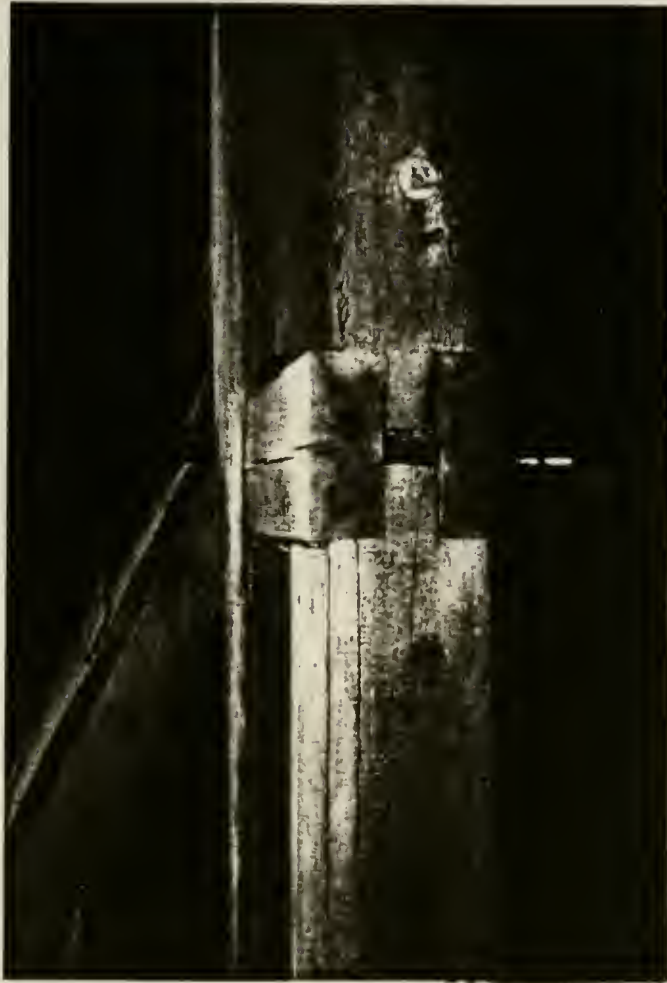
Plate 49: Detail of 1826 threshing floor framing, showing evidence of cut cross member

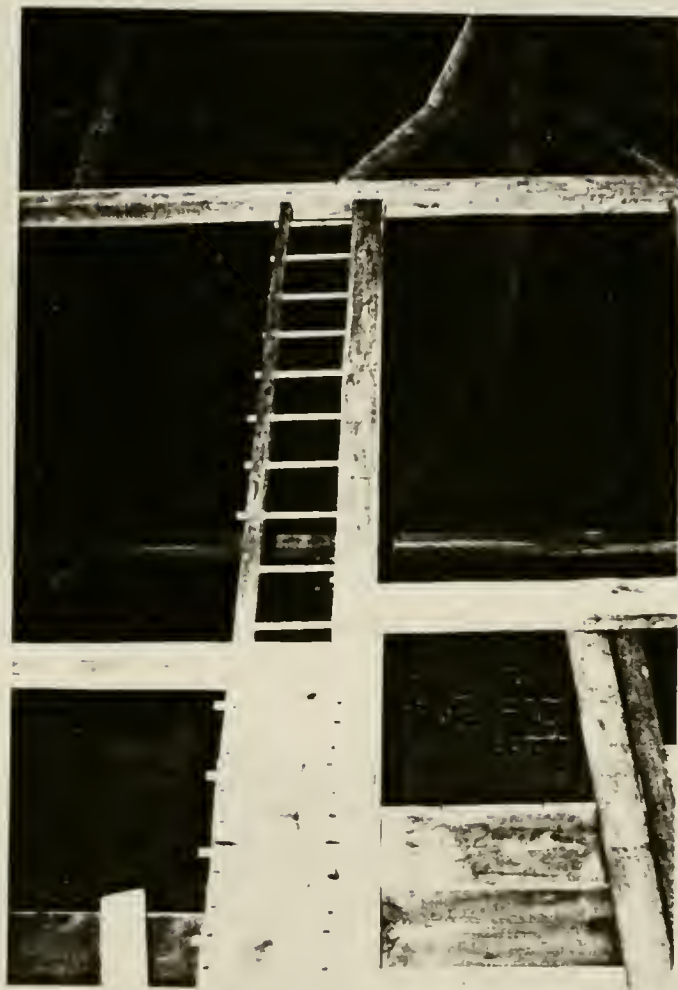
Plate 52: View west of 1826 structural framing, which employs a 3-bay H-bent design and system of diagonal braces at roof level. Note original west gable end in background.

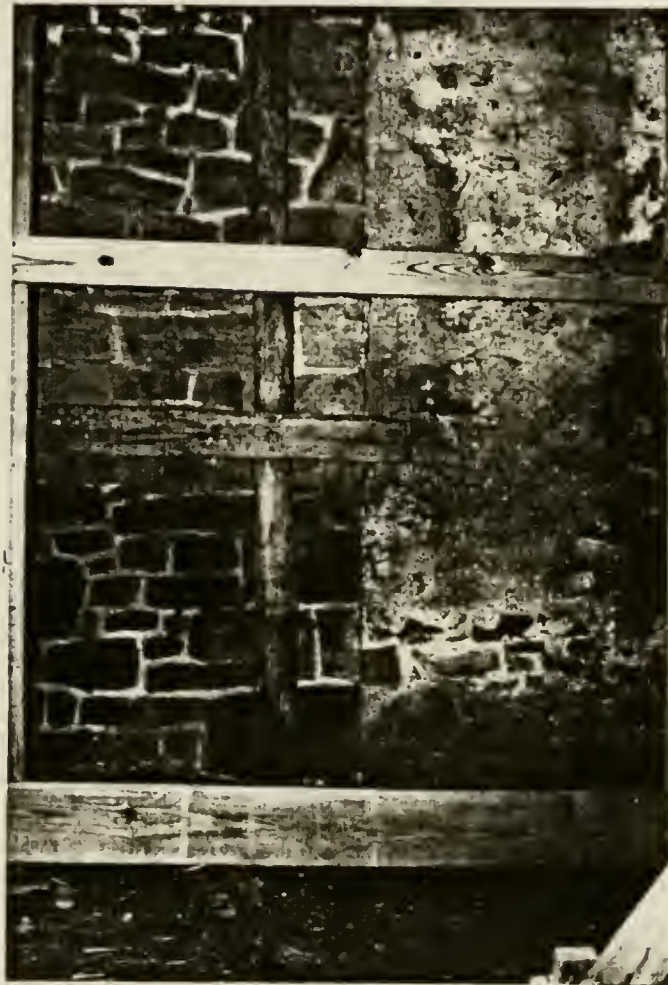
Plate 55: North elevation in carriageway section, showing exposed vertical seam between 1826 and 1845 sections. No attempt was made to disguise the joint on this elevation as opposed to south elevation.
